Articulating Compensator

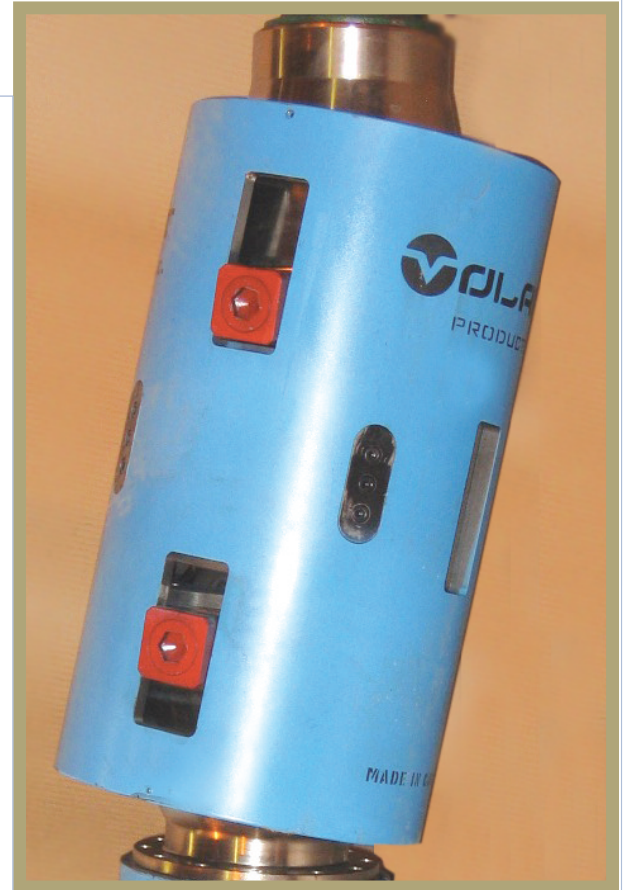
Volant has developed the Articulating Compensator to reduce the risk of running casing utilizing top drive equipment. Whether the operator chooses to utilize nubbins or a casing running tool, the Articulating Compensator can be installed in line to reduce the risk of connection damage by enabling off axis alignment through the tool. A built in axial load compensator enables "soft stabbing" of the casing further reducing the risk of connection damage.

- > Torsion Capacity 40,000ftlb
- > Hoisting Capacity 500,000lbs
- > Total Swing 6 inches
- > Pressure Compensated Axial Stroke 6 inches
- > Upper Connection 4.5" I.F. Box
- > Lower Connection X-Over to specified connection
- > Overall length 39" (c/w x-over to 4.5" I.F. pin)
